AKTUALITA Z TESTOVÁNÍ V TERÉNU: PROVEDENÁ KONTROLA OTVORŮ PRO ŠROUBY LETADLA CESSNA 402B VÍŘIVÝMI PROUDY

FIELD TESTING UPDATE: CONDUCTED CESSNA 402B BOLT HOLE EDDY CURRENT INSPECTION

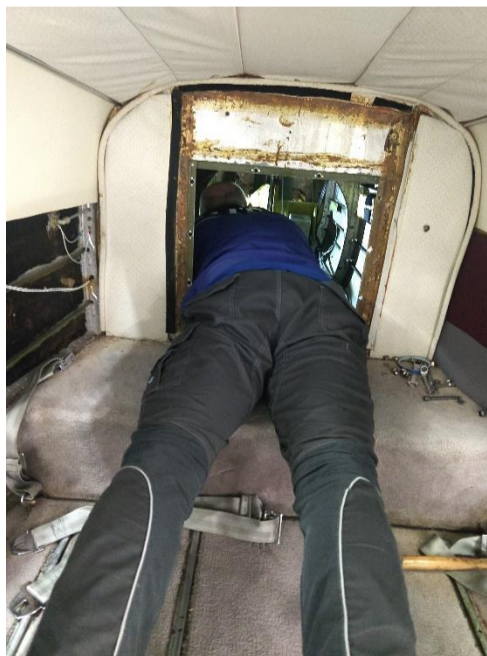
We would like to share with you another day in the field. We performed thorough testing on the Cessna 402B using the Bolt Hole Eddy Current method in accordance with SID 55-30-04.

This time everything was without a finding.
