## ZPRÁVA Z TERÉNU: KONTROLA OKEN KOKPITU CESSNY 525B

## FIELD UPDATE: TESTING THE COCKPIT SIDE WINDOW FRAME ON THE CESSNA 525B

At the end of 2023, we were on-site at Ruzyně airport. Our focus? Testing the cockpit side window frame (TASK 53-20-01) on the Cessna 525B. This involves inspecting cockpit window frames, primarily around the rivet areas.

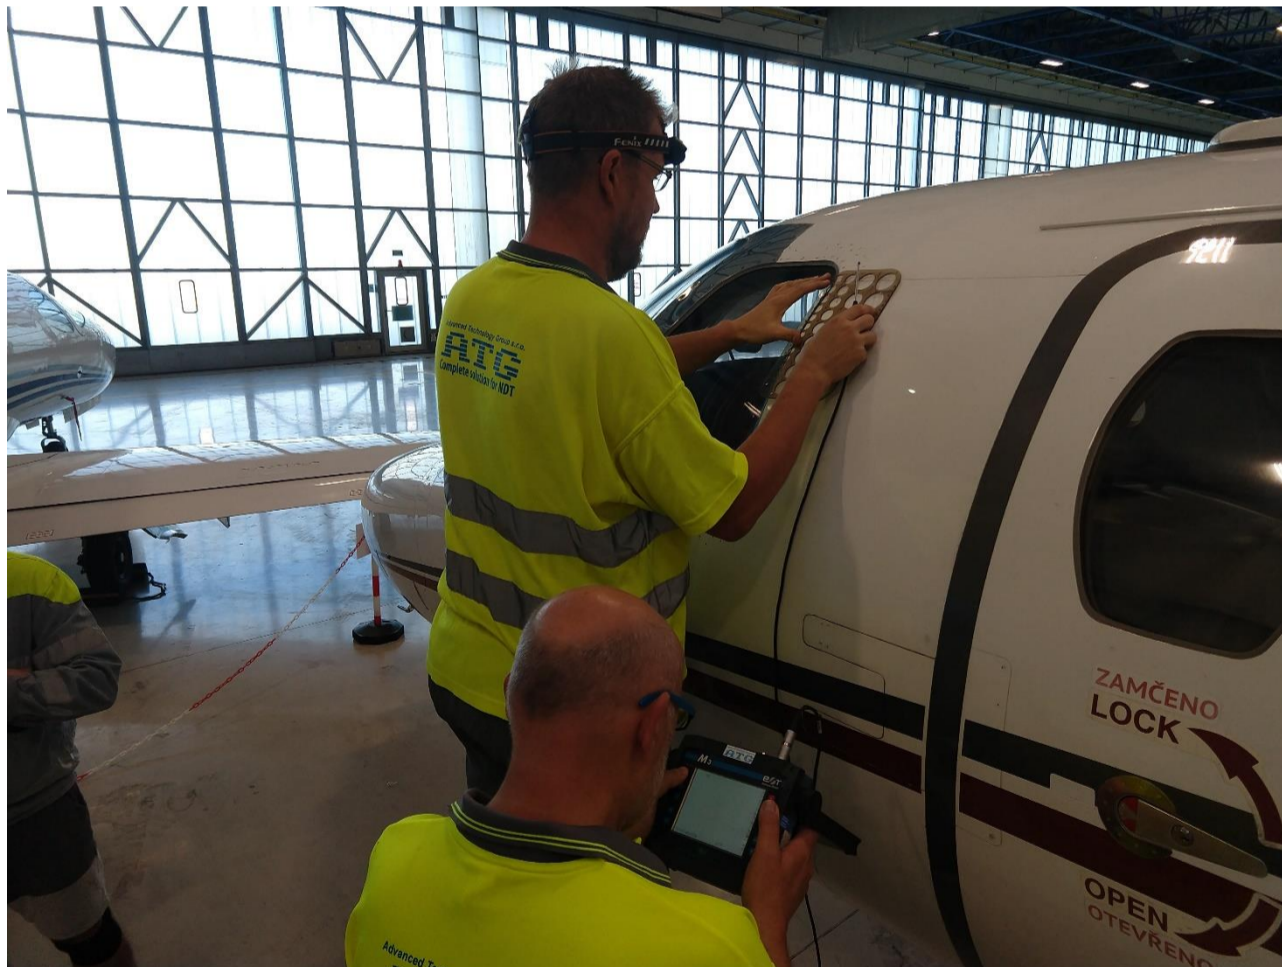
Precision in inspection is paramount in ensuring the safety and reliability of aviation components and air traffic. We employed the Eddy Current method for testing, utilizing the Elotest M3 equipment from Rohmann GmbH.
